# DEMONSTRATED LONGEVITY IN AN FGD REPAIR

ID: 892

Coal-Fired Power Plant - Cumberland City, Tennessee USA

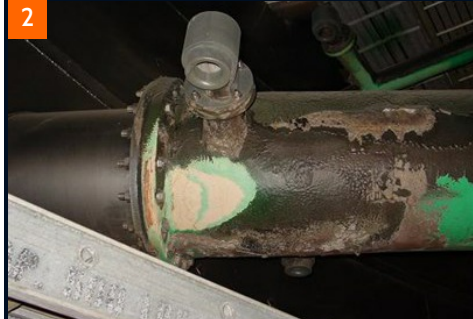
1. Exterior of the FGD at the spray level
2. Severely damaged FRP pipe caused by lime slurry
3. Completed Belzona application to one of six lime slurry header pipes
4. Belzona repair after seventeen months in service

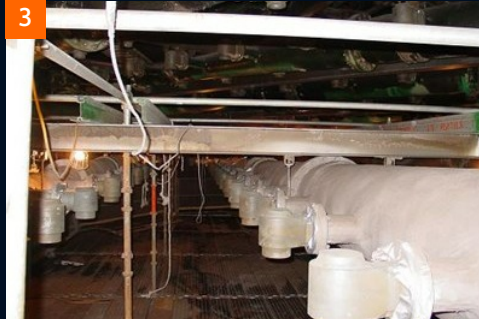
Lime slurry from the four spray levels above had caused an existing polyurea coating to fail exposing the relatively soft FRP piping to the erosive forces of the lime slurry. Should the piping become holed, side streams would decrease the overall scrubbing efficiency resulting in increased operating costs.

Belzona® 5891 and Belzona® 1391 were applied in accordance with a modified Belzona Know-How System Leaflet VPF-2.

Replacement of existing tapered FRP piping would have required an unacceptably long lead time and was considered prohibitively expensive. Belzona was selected because the repair can be conducted quickly and inexpensively in situ while providing the required abrasion, temperature, and chemical resistance.
