# WELLHEAD LEAK REPAIR

ID: 8924

## PROBLEM

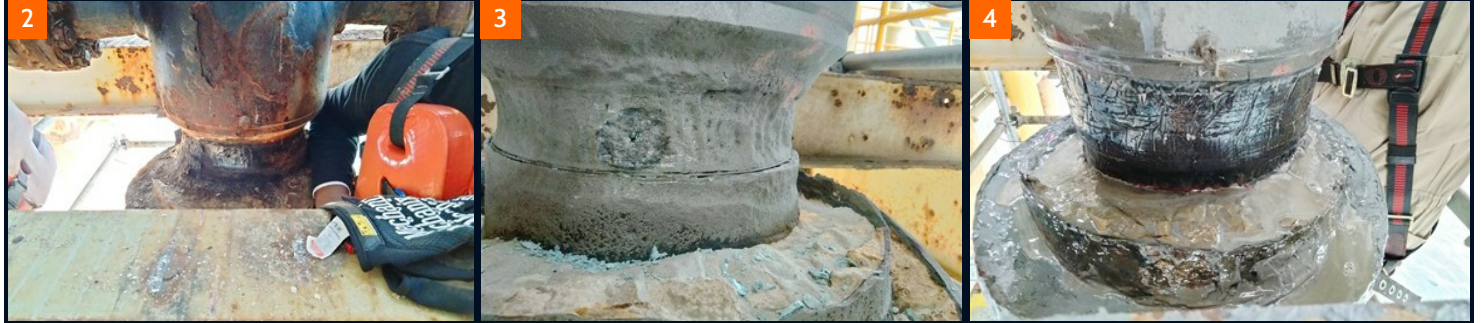
A hole present in the casing did not allow gas lift pressure to accumulate. If the accumulation of pressure is not achieved, then oil cannot be produced.

1. Original condition of the leaking wellhead.
2. Defect located and prepared for plug with Belzona 9611.
3. Surface after grit blasting.
4. Hole repaired with SuperWrap II.

The defect (hole) was plugged with Belzona 9611. Then, the surfaces were rebuilt with Belzona 1121. Finally, the SuperWrap II system was applied to repair the area and offer structural integrity.
