# TOWBOAT FENDER REPAIR

ID: 8939

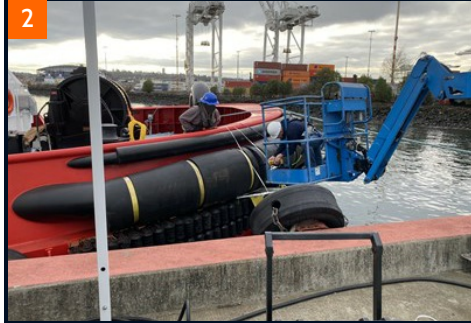
INTERLOCKING FENDER DELAMINATED.

1. INTERLOCKING FENDER SEAM SEPARATED.
2. PREPARING THE SUBSTRATE.
3. ATTACHING FORM.
4. COMPLETED REPAIR.
