# BELZONA SEALS TAILSHAFT LINER

ID: 899

240mm Tailshaft from a 2500 Tonne Deadweight Coastal Products Tanker, passing through aft peak tank.

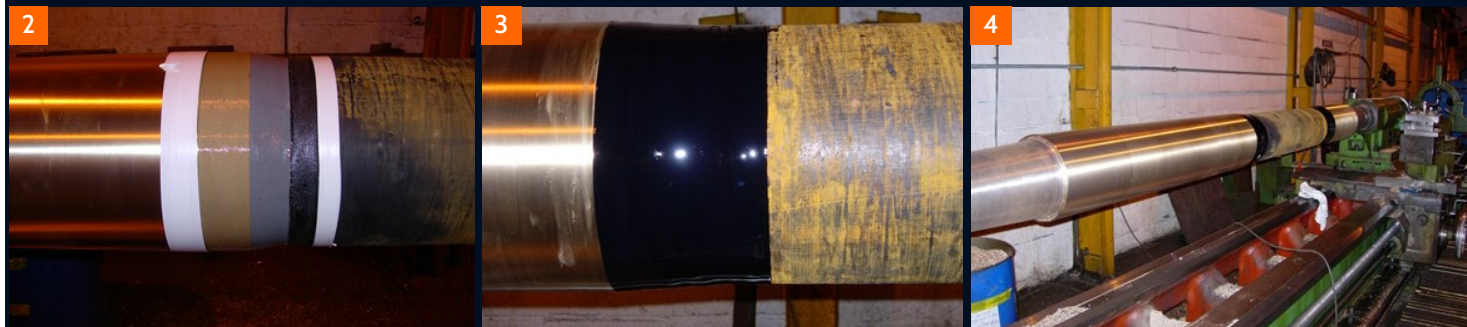
The bronze liners had worn and required changing. The body of the tailshaft was coated with a vulcanized rubber lining which was generally intact. Following changing of the Bronze liner the Rubber lining was damaged and not sealing. This could have lead to crevice and bi-metallic corrosion.

1. New liner fitted to shaft
2. Preparation and conditioning complete
3. Belzona 2141 completed application
4. Tailshaft complete – all works were undertaken on the lathe

The rubber lining was cut clean away, and roughened using the Belzona Roughing brush. The Bronze liner was tapered to meet the rubber, and left with a rough thread and rebate groove. Following gritblasting of the shaft, Belzona® 1111 was applied between the liner and lining. After Conditioning, Belzona® 2141 was applied to seal between the rubber and the bronze.
