# REPAIR OF DAMAGED PUMP PARTS

ID: 9013

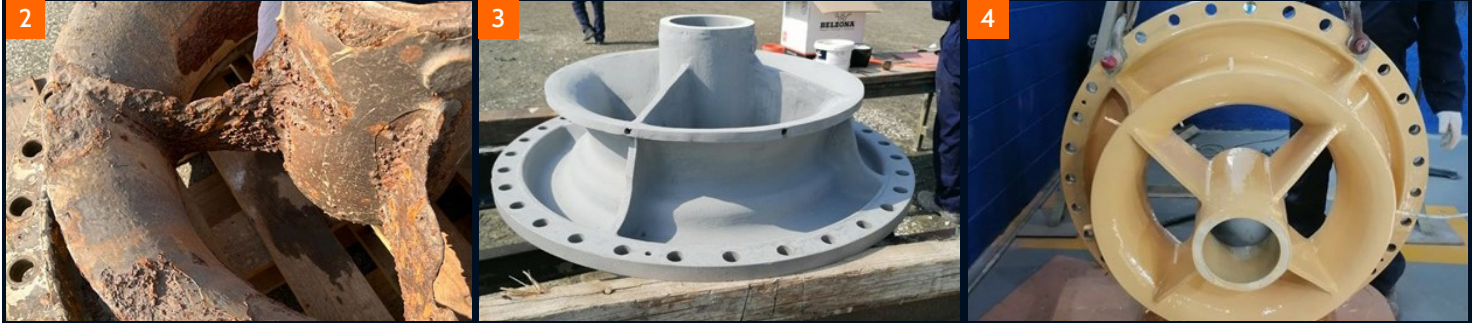
The pump part was heavily corroded and eroded and not in a condition to use

1. Initial condition
2. Initial Condition
3. After repair with Belzona 1111
4. After coating with Belzona 5821

The application was completed in accordance with Belzona System Leaflets CEP 01, CEP 03 and CEP 05
