# BROKEN CAST ALUMINUM MOTOR COVER REPAIR

ID: 9023

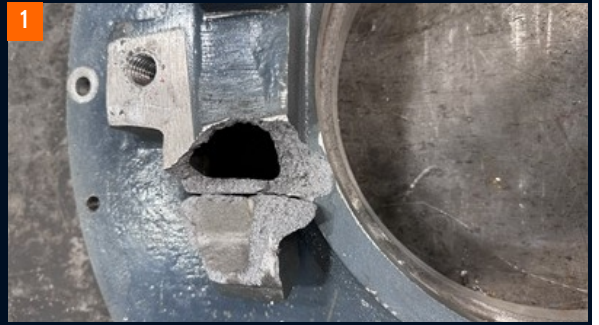
Part of the cast aluminum motor cover was broken off. Welding, replacement and cold bonding were the options.

1. Broken Piece
2. Applying 7311 to Cover
3. Applying 7311 to Broken Piece
4. Completed Application
