# FRACTURED GRP PIPE REPAIRED WITH BELZONA SUPER WRAP 2

ID: 9033

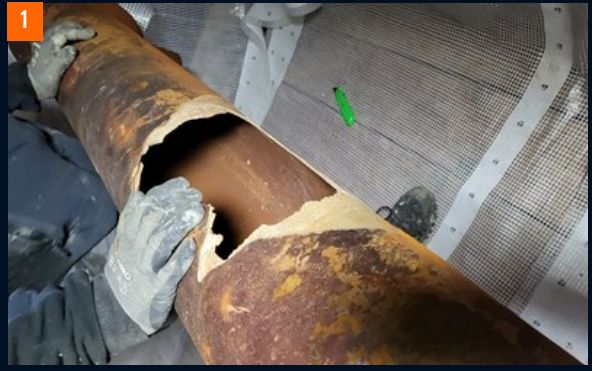
A GRP pipe had shattered causing a partial shutdown of a power plant

1. Fractured 8" GRP pipe
2. Steel plate bonded over the hole with Belzona 1212
3. Damaged area reinforced using Belzona Super Wrap 2
