# BELZONA QUICKLY SAVES THE RIPPED CONVEYOR BELT

ID: 9044

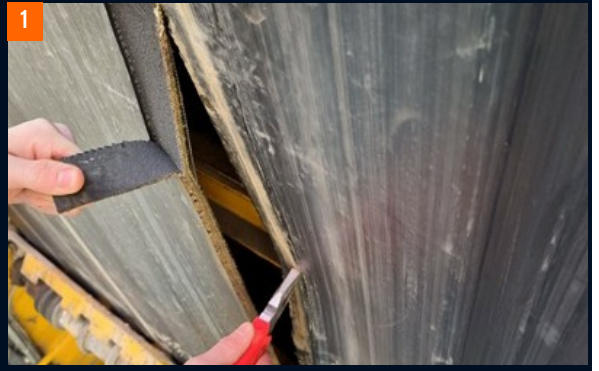
An incident in production caused damage to a conveyor belt. The belt was ripped through the middle in length of more than 1 m. The production had to stop.

1. Ripped conveyor belt
2. First layer of the belt peeled off in order to install belt fasteners properly
3. Belt fasteners installed
4. Belt fasteners protected with Belzona 2311
