# GALVANIC CORROSION IN WATER MAKER REPAIRED WITH BELZONA

ID: 908

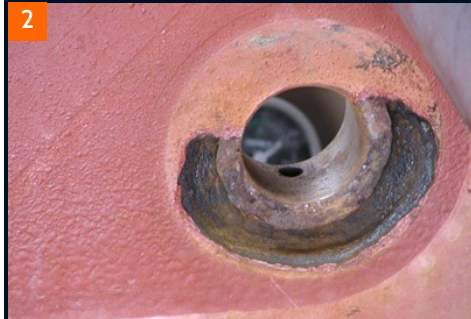
Galvanic corrosion caused by the failure of the insulating gasket caused severe corrosion and under cut the existing glass flake coating. Base material was Carbon Steel plates were Titanium.

1. Water Maker
2. One of the areas of galvanic corrosion
3. Forming the repair
4. Repair completed, perfectly formed flange face

Weld repair would have damaged more of the existing coating and onsite machining would have had to be used to reinstate the sealing faces and the bore of the nozzles. Time was key factor as this was an emergency repair situation.
