# PUMP OIL SUMP NOT ALL ITS "CRACKED" UP TO BE

ID: 910

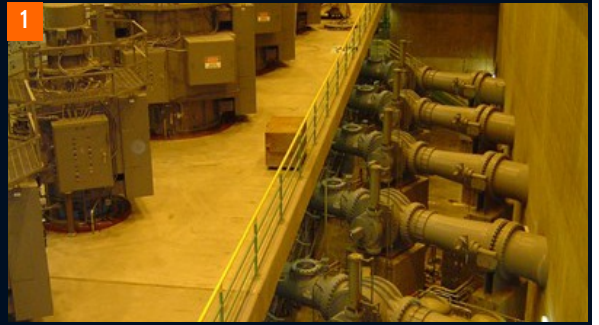
1. Pump Station
2. Clean, Dry and Abraded
3. Conditioner Applied
4. Application of the Belzona 2111

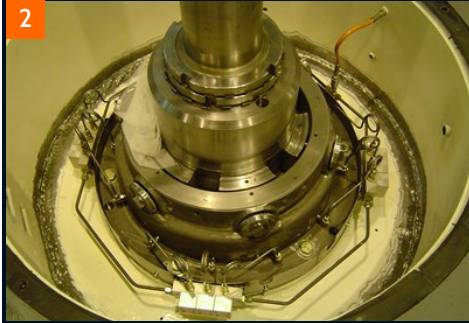
Large oil sump for the shaft bearing at the top of the pump was experiencing cracking from harmonic vibration. As the company that produced the pump was no longer in business and available parts are difficult to find and very expensive, \$1000 of Belzona saved them over \$60,000 worth of replacement parts, labor and downtime. In addition the Belzona solution eliminated the problem from occurring again.
