# REPAIR, REBUILDING AND PROTECTION OF IMPELLER IMPELLER WITH BELZONA TECHNOLOGY

ID: 9132

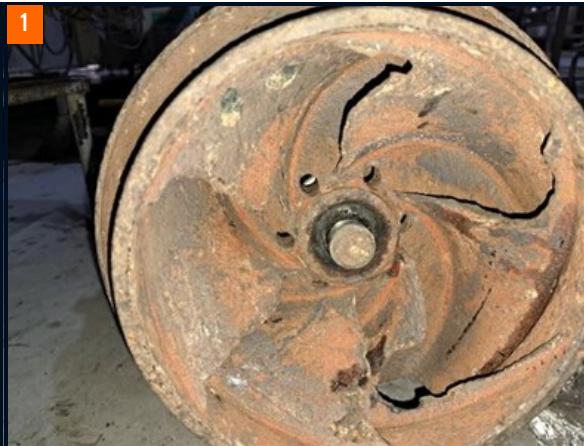
The impeller showed generalized wear, exhibiting the most damage on the vanes and on the trailing edges. This situation generated a loss of efficiency of the pump, the solution due to the damage of the part was to decide between rebuilding or replacing it.

1. Equipment to be repaired
2. Sandblasted Impeller.
3. Rebuilding Stage.
4. Completed Application.
