# FLANGE REBUILDING AT A FERTILIZER PLANT

ID: 9156

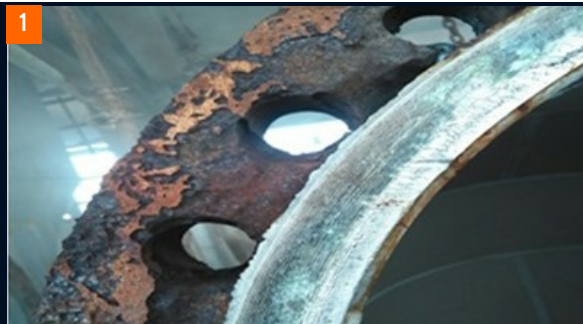
There was evidence of bimetallic corrosion and erosion in the 24" elbow between the flange and the seal, which was perforated and thinned the thickness of the flange.

1. View of damage to the flange
2. Surface preparation.
3. Final application.
