# AXIAL FLOW PUMP REBUILD & COATING

ID: 9186

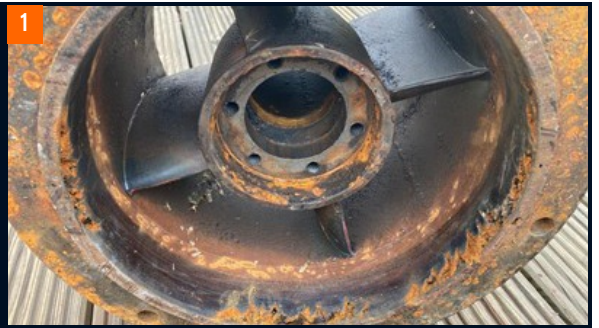
An axial flow pump had become damaged by erosion & corrosion in service leading to a loss in efficiency

1. Damaged pump body
2. Surface preparation
3. Rebuilding with Belzona 1111
4. Finished Belzona coating
