# REPAIR AND PROTECTION OF INTER STAGE CHILLER TUBESHEET

ID: 9191

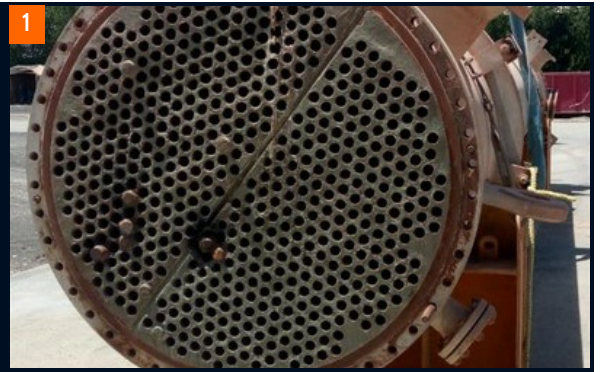
Tubesheet suffering from galvanic corrosion. Erosive damage at the division bar was observed; severe erosion due to the slurry medium.

1. Initial condition of the tubesheet
2. Eroded tubesheet and damaged division bar slot
3. During application
4. Completed application

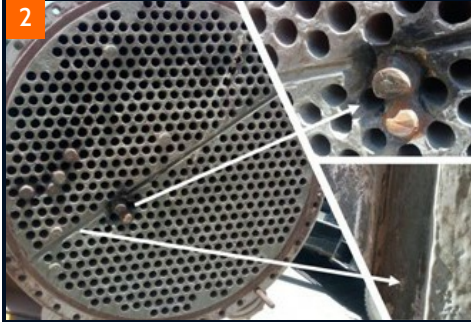
The tubesheet had been deeply eroded and replacement was the preferred option. As there was no standby equipment to replace, the customer was in a situation to repair the damaged chiller. Belzona repair, rebuilding and protection was presented to the customer, who was pleased and satisfied with the method statement based on Belzona heat exchanger repair methods.
