# METSO FLY ASH PUMP

ID: 9195

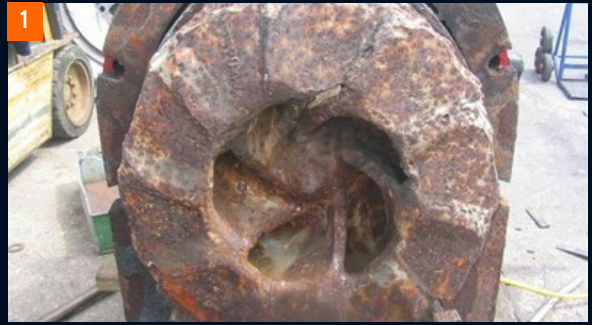
A pump used to transport fly ash was suffering severe erosion & corrosion in service. Due to the harsh conditions pump parts had to be replaced every 6 months.

1. Damaged parts after service
2. Rebuilding of casing
3. Impeller rebuild & lining
4. The lining condition after 18 months of service

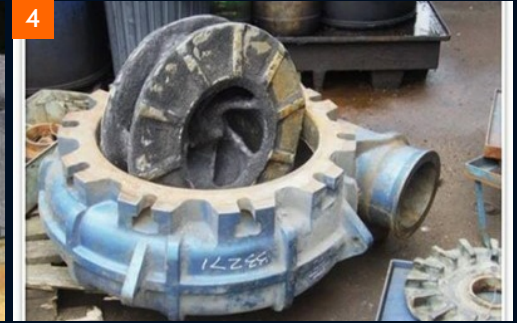
The original parts were only lasting 6 months. Using Belzona linings took the in service time to over 18 months. These parts could then be relined & put back into service instead of being scrapped.
