# SILL REPAIRS WITH BELZONA

ID: 923

## PROBLEM

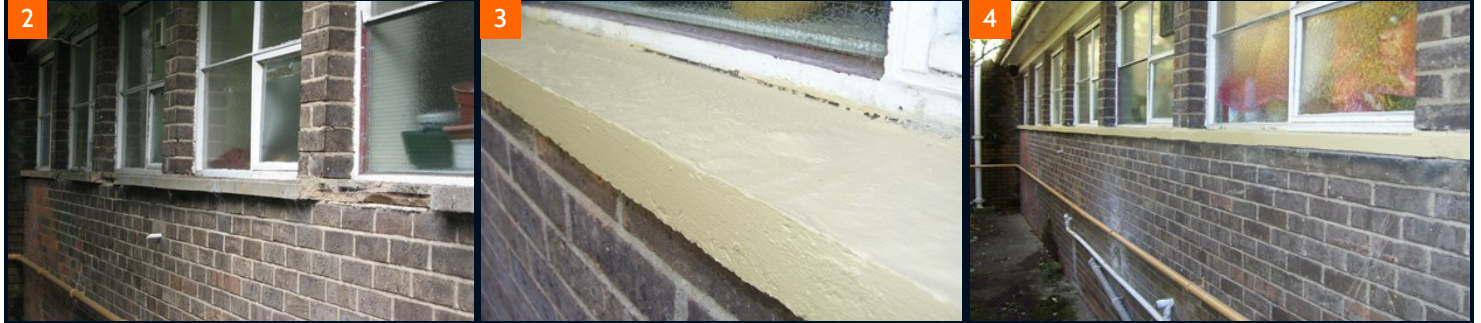
A childcare centre were having safety issues with pieces of concrete falling from window sills due to the spalling concrete.

Damage to concrete window sills due to corrosion of reinforcement bars.

1. Damaged sills before the repair
2. Exposed and corroded reinforcement bars
3. Rebuilt using Belzona 4141 & coated with Belzona 5151
4. Completed repairs
