# COMMON PROBLEM WITHIN PHARMACEUTICAL INDUSTRY

ID: 9236

## PROBLEM

Several deep cracks in concrete around bund area.

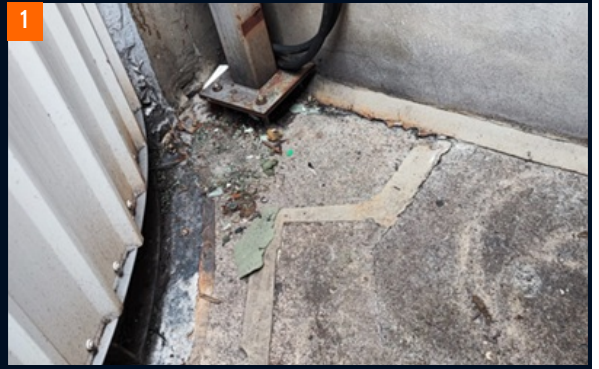
Several deep cracks causing leaks in bund area.

1. Clears signs of chemical damage on bund floor
2. Failure of tank base seals leading to moisture ingress
3. Repairs with 4131 and sealing of cracks with 4361
4. More repair areas

- Area was cleaned of debris and an abrasive wheel was used to provide a rough surface for the purpose of adhesion.
- Belzona 4911 applied as a conditioner and allowed to dry.
- Initial coat of Belzona 4361 applied and allowed to become touch dry.
- Second coat was applied after 4 hours.
