# BELZONA REPAIRS A BROKEN HYDRO ELECTRIC TURBINE RUNNER

ID: 924

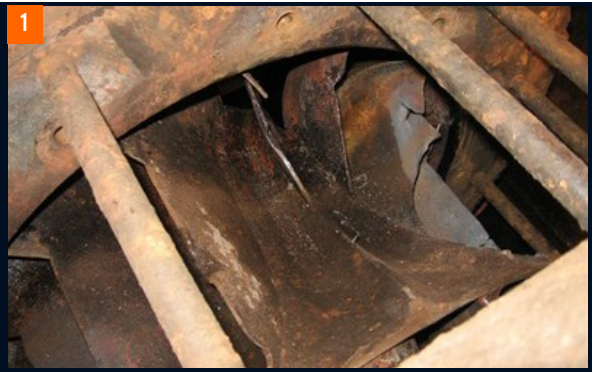
Loss of balance and horsepower.

Wicket gate came loose and fell into turbine breaking three blades on runner.

1. Broken runner blade
2. Expanded metal tack welded
3. Blades rebuilt with Belzona 1311
4. Completed application after coating runner

Application carried out in accordance with the Belzona Know-How System Leaflets CEP-1 & -3. Expanded metal was tack welded in place before rebuilding with Belzona® 1311. Complete runner then coated.
