# BELZONA MAINTAINS FRANCIS TURBINE

ID: 928

Complete Overhaul of all the parts and sections of a Francis Turbine. The turbine needed maintenance after 15 years of operation.

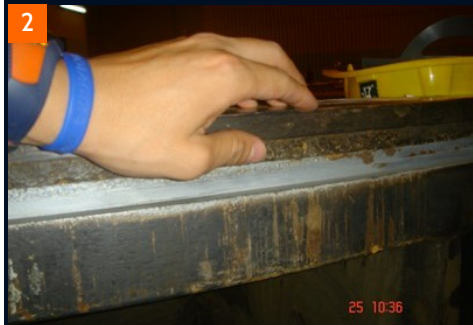
1. View of diffusers
2. Damage in seal perimeter
3. Machined area prior application of Belzona 1111
4. Final application of Belzona 1111 and Belzona 1321

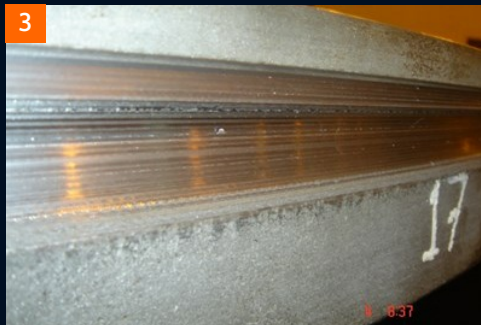
The water had produced an erosion/corrosion effect in several sections of four different parts of the Turbine. The biggest damage was located in the seal perimeter of the facing plate.
