# REPAIR AND PROTECTION OF OIL/WATER SEPARATOR WITH BELZONA

ID: 93

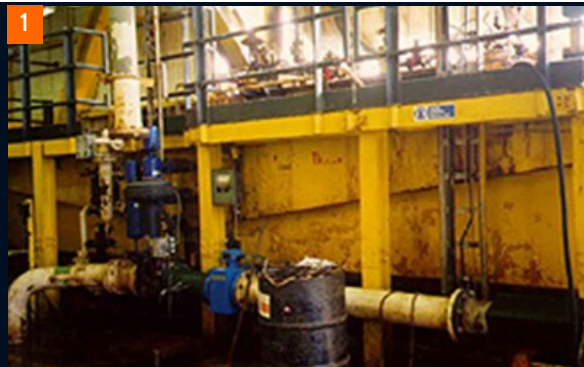
1. General view of the unit
2. Bonding doubler plates to holed areas
3. Belzona 1391 providing complete protection to the separator internal surfaces

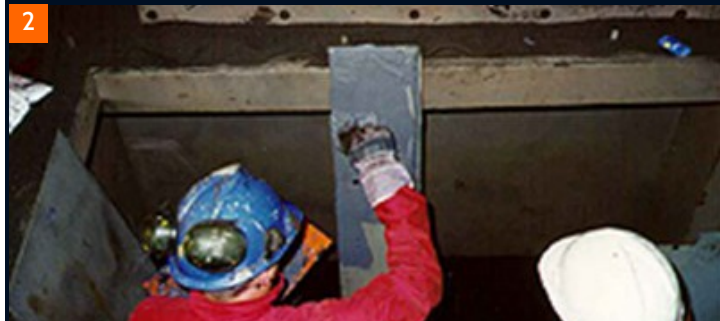
The original glass flake system failed in the severe erosion-corrosion conditions leading to holing of the unit

Application was carried out in accordance with Belzona® system leaflets TCC-1, TCC-2 & TCC-5. Doubler plates were bonded over holed and deeply pitted areas before applying Belzona® 1391 to provide erosion-corrosion protection over the entire area.
