# BELZONA REPAIRS A TRANSFORMER

ID: 9301

A large transformer in Amsterdam showed leaks on the flange face of the cover. Since the cover is full of connections and connections, it is not possible to detach the cover and thus replace the gasket.

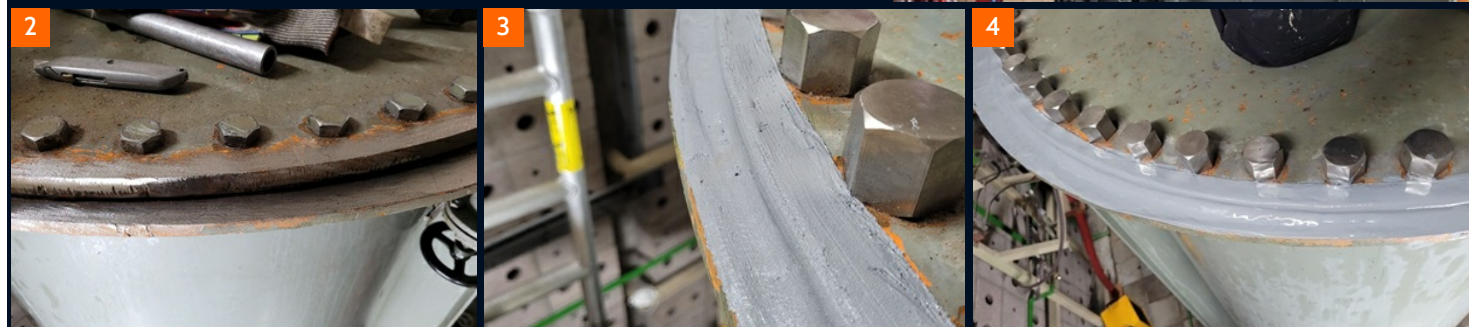
1. Transformer to be repaired.
2. Area of the transformer leaking.
3. Belzona 1161 applied
4. Application complete with a coating of Belzona 5831 over the Belzona 1161

Before the Belzona products can be applied, it is important that the surface is cleaned and roughened. The edges are then sealed with the oil-tolerant paste for metal repair, the Belzona 1161. This is applied in combination with the Belzona 9341 reinforcement sheet.

The repair is finished with Belzona 5831 for extra protection. This epoxy coating for corrosion protection is again oil tolerant. The combination of products used repairs the transformer, in such a way that it will be leak-free for a long time. The application was carried out in accordance with Belzona system leaflet GSS-08.
