# TORN CONVEYOR BELT REPAIRED WITH BELZONA ELASTOMERS

ID: 9345

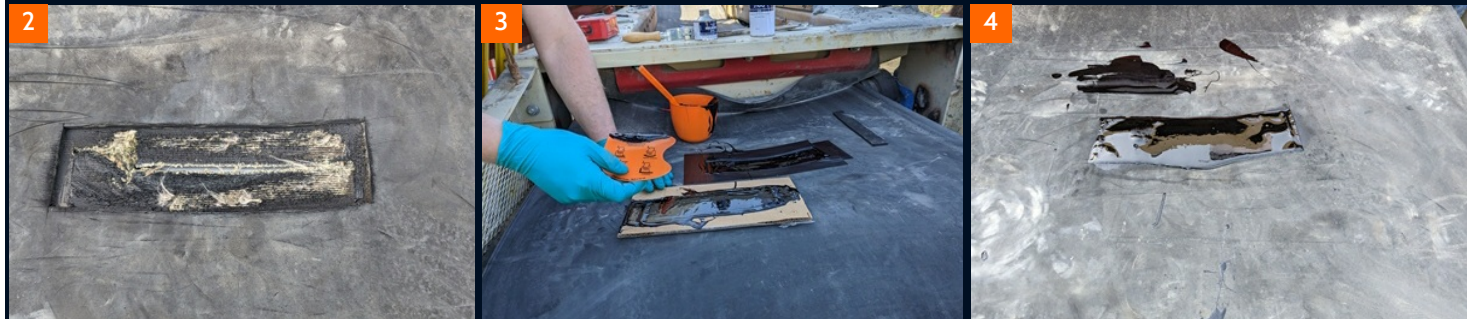
Conveyor belt was ripped and needed repair before being put back in service

1. Damaged belt
2. After surface preparation was completed
3. Belzona 2111 application
4. Completed repair

The ends of the crack were drilled to prevent propagation. Then, the outer layers of the belt were removed and the rubber was properly abraded before application of the Belzona products. The surface was conditioned with Belzona 2911 and then rebuilt with Belzona 2111 reinforced with Belzona 9341
