# SUPERWRAP II APPLICATION TO GFRP SPOOLS

ID: 9364

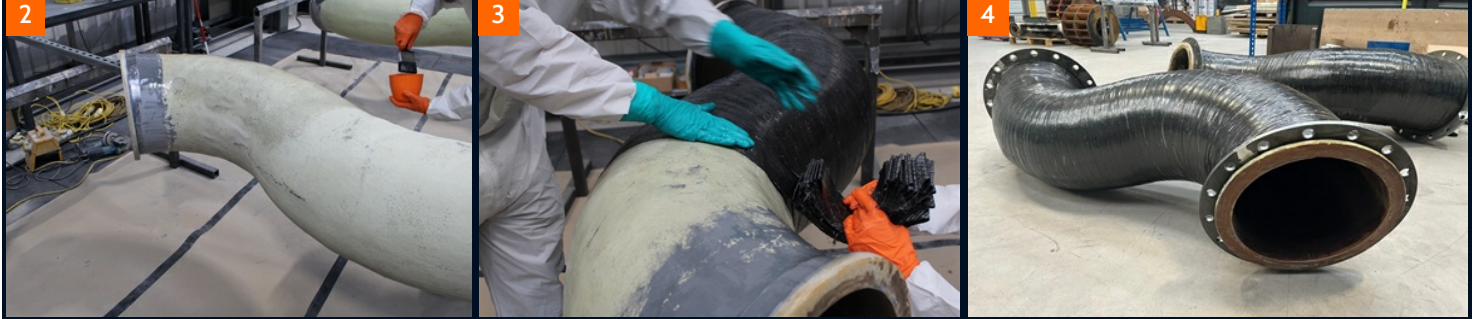
Deteriorated / aged GFRP pipe spools that in turn have cracked at the flange to pipe spool area and are leaking

1. GRP Pipe Showing Crack
2. Plates cold bonded over cracked area
3. SuperWrap II In progress
4. Wraps Completed

Frost blasted using conventional blasting within the BUK blast facilities. Cold plate bonded using Belzona 1111 (Super Metal) then SuperWrap II applied utilising 84mm wide sheet due to geometry.
