# CRACK REPAIR - SEA WATER DISTILLER

ID: 9404

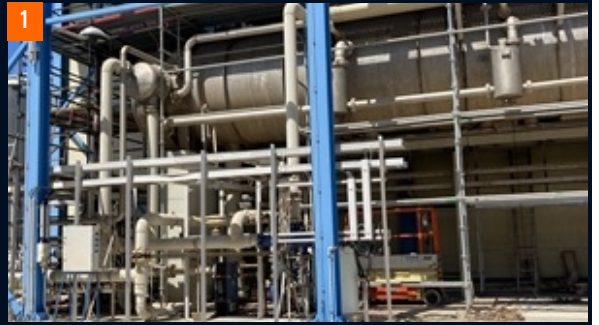
The customer faced cracks at sea water distiller . Due to the cacks the sea water was mixed with the clean water and the unit were out of order.

1. Sea water distiller
2. Before the surface preparation
3. Before preparing surface
4. Surface coated with Belzona 1391T
