# PROPELLER REPAIR AND PROTECTION

ID: 9409

Cavitation damage on propeller and hub

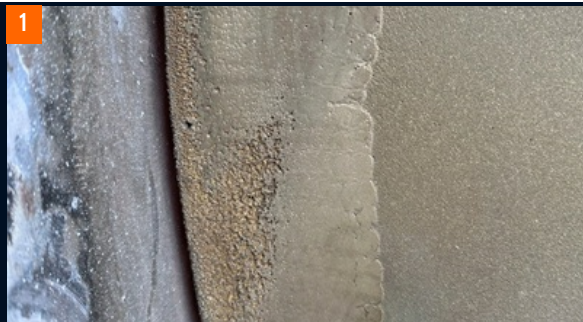
1. Damage to propeller
2. Belzona 1311 applied in areas of cavitation
3. Belzona 1341 grey applied as first coat
4. Belzona 1341 blue applied as second coat
