# STAINLESS STEEL PROPELLER REPAIR AND PROTECTION

ID: 9411

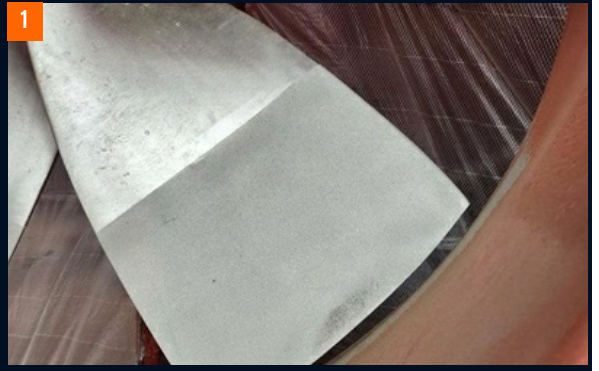
Areas of cavitation damage

1. Tips of blades grit blasted
2. 1st coat applied was Belzona 1341
3. 2nd coat applied was Belzona 2141
4. Vessel ready to return to service

Tips of blades were grit blasted to a minimum of 3mils. Cavitation pockets were filled with Belzona 1311. For protection, Belzona 1341 was applied in a 10mil coat. Belzona 2941 surface conditioner was then applied followed by a 30mil coat of Belzona 2141.
