# SULFURIC ACID FLANGE REPAIRS WITH BELZONA 4301

ID: 9415

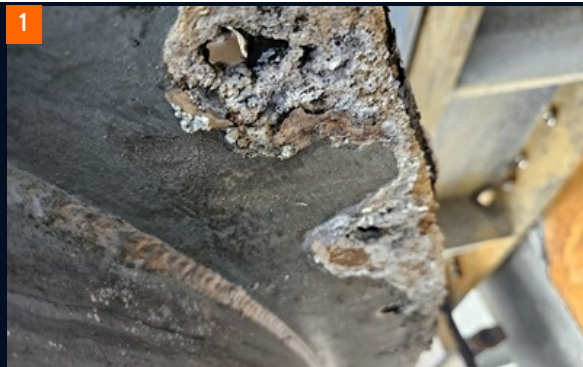
Damaged Flange from sulfuric acid.

1. Flange with Sulfuric Acid Damage
2. Flange After Repair with Belzona 4301

-prepared the substrate on the damaged area as listed and points surrounding the damaged area.

-Applied Belzona 4301 system to the area of repair as listed.

-Allowed full cure of product prior to applying any chemicals, this took 4-Days at 86 degrees F.

Profile of 3 mils

Blasted clean to SSPC SP 10

Utilized stiff Bristle brush to apply fully conditioned Belzona 4301
