# FLANGES LEAK SEALED IN A PETROCHEMICAL PLANT.

ID: 9423

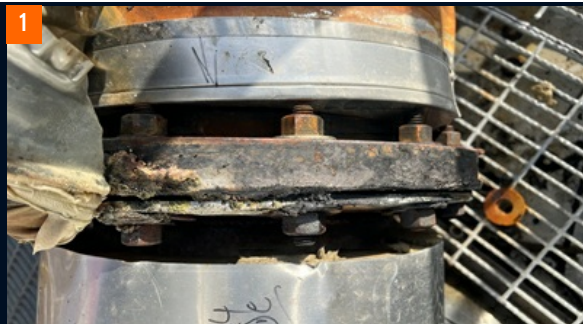
Product was leaking from flanges and needed sealing for environmental compliance.

1. One of the flanges before surface preparation.
2. Flange after surface preparation.
3. Flange after sealing with Belzona 1212.
4. Repair completed with Superwrap II to protect against moisture ingress.

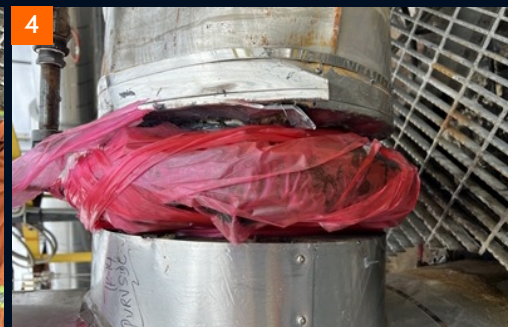
Belzona repair solution was able to achieve seal the leaks under 6 minutes , allowing for a more robust superwrap application. The overall repair was carried out based on customer's expectation and no leak was experienced after an inspection was carried out 3 months later on the flanges.

- Flanges were cleaned using Belzona 9111 and a power tool.
- Belzona 1212 was used to seal the leak.
- Belzona Superwrap II resin and accessories were used to give further protection.
