# WIND TURBINE BLADES

ID: 9436

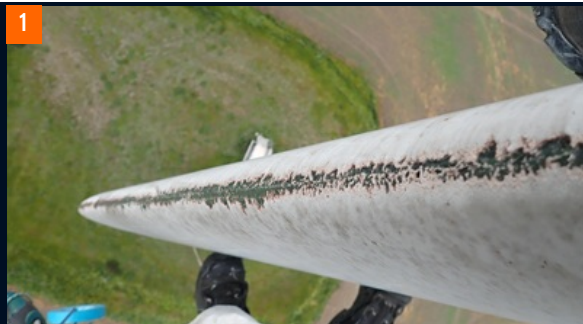
Due to natural wear and weathering, 14 onshore wind turbines were exhibiting damaged leading edges. The turbines were outside of the Manufacturer's warranty period.

1. Damaged leading edge
2. Wind turbine in need of repair and protection
3. Application of Belzona 5711 and Belzona 5721 completed

Surface preparation was carried out, followed by the direct application of 90 kg (198.4 lbs) of Belzona 5711 from self-mixing cartridges onto the blade. The repair area was contoured using a piece of Belzona mixing board. Once cured, a visual inspection was conducted to ensure the application's readiness for overcoating with 144 kg (317.5 lbs) of Belzona 5721. Using a short-bristled brush, this system was then applied to the leading edge and left to cure. The application was carried out in accordance with Belzona System Leaflet FBC -16.
