# BELZONA 1111 CAN REBUILD SEVERE PUMP CORROSION

ID: 9451

Heavy metal loss on the internal components of a multi-stage vertical salt water pump.

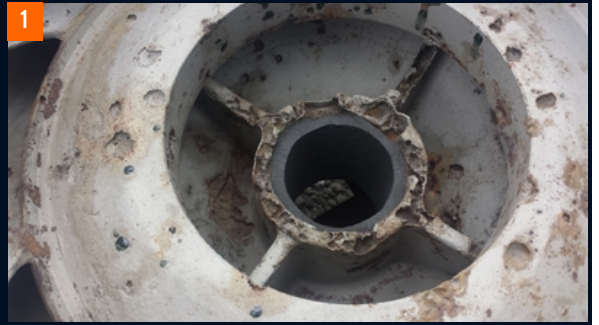
Deep pitting on the internal parts were causing poor performance with this pump.

1. Original condition after opening the pump.
2. Up close view of the damage.
3. Belzona 1111 filling in all of the damage and correcting the profile.
4. A look at the other side of the piece after the Belzona 1111 application.

Grit blasting to prepare the surface according to the Belzona 1111 Instructions For Use. Then the Belzona 1111 was applied by hand using the Belzona applicator. Once cured, the application was hand sanded to the original profile and coated with two full coats of Belzona 1341N.
