# BELZONA REBUILDS AND PROTECTS AN OUTBOARD

ID: 9459

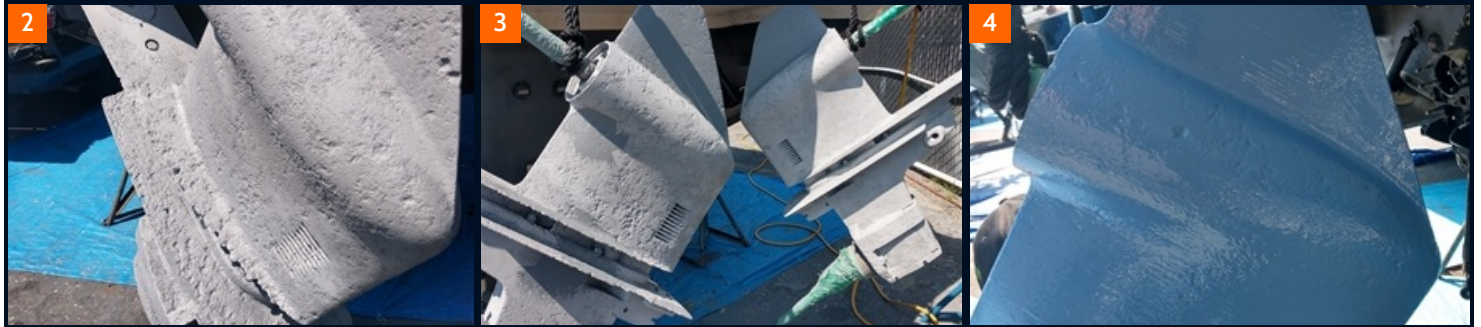
Salt water had corroded this outdrive.

The original coating had failed and allowed the salt water to penetrate and corrode the casings on these yacht outboard drives. The options were to either repair them or replace them. Both units were rebuilt, and protected for under \$2000 USD which would not even bought one replacement outdrive for this yacht.

1. Both outdrives sandblasted and ready for application.
2. Up close, showing the erosion damage.
3. Belzona 1111 being applied to rebuild the missing material and smooth over the pitting.
4. Belzona 1341 applied to protect the outdrives.

The application areas were grit blasted and washed to remove the salt water. Belzona 1111 was applied by applicator to rebuild the missing areas and smooth out the pitting. Once firm, Belzona 1341 was applied in two coats to prevent further damage.
