# BELZONA ELASTOMER REPAIRS DAMAGED RUBBER LINING OF SEAWATER LINE FILTER

ID: 9483

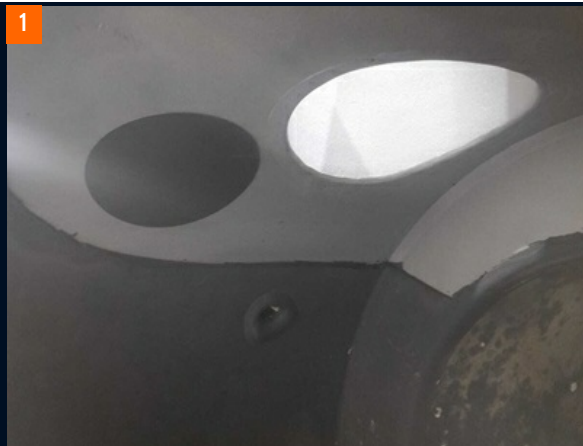
Damaged existing rubber lining, the metal shell was punctured due to liquid medium contact to metal which create pinholes on the nozzle welding joint.

1. After surface preparation AND DURING SALT CONTAMINATION TEST
2. COMPLETED SURFACE CONDITIONER APPLICATION.
3. COMPLETED FLANGE FACE FORMING USING FLANGE FACE FORMER.
4. RUBBER LINING REPAIR COMPLETED

The application was done using a stiff bristle brush, provided plastic applicator, fabricated flange face former and a fabricated metal using Belzona 2921 as the surface conditioner and Belzona 2211 as the rebuilding material.

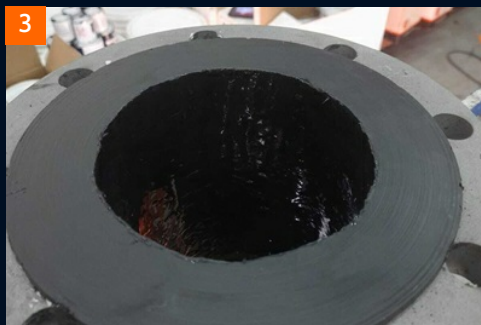
Flange Face Forming is required on the worn out rubber lining of the flange face.
