# 24INCH PIPE LEAK REPAIR OF USING BELZONA 1212 AND SUPERWRAP II

ID: 9489

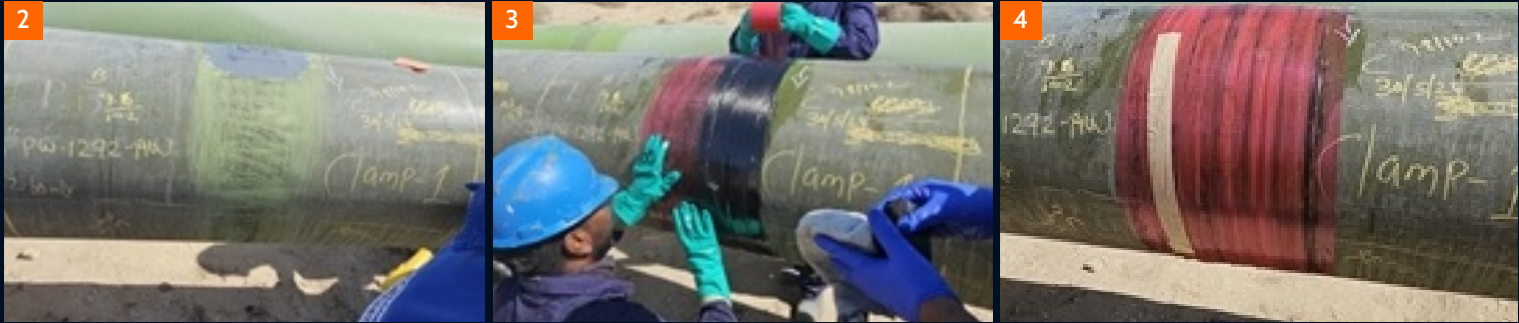
The client is experiencing wall thickness loss which has led to a 6-7 cm hole in the 24-inch crude oil pipeline. The excessive erosion and corrosion of the crude oil is causing the leaks. The pipeline is operating at ambient temperature and a pressure of up to 5 bar.

1. Pipe defect prior to Belzona application
2. Steel plate bonded using Belzona 1212
3. Application of Belzona Superwrap II
4. Completed Belzona Superwrap II repair

Surface preparation was completed using power tools. Belzona 1212 along with patch plates were applied to seal the defect area. Once Belzona 1212 fully cured, Belzona Superwrap II application was carried out to consolidate the repair.
