# REPAIR OF PVC PIPE WITH LEAK FROM FAILED FIBER GLASS INSTALLATION

ID: 9493

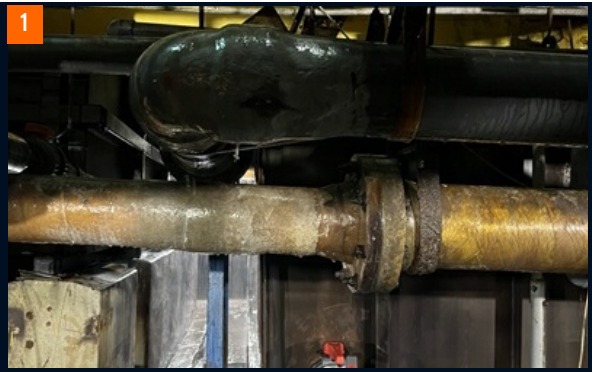
Major leaks was experienced from a failed fiber glass installed earlier by customer to fix problem.

1. Fialed fiber glass
2. Newly installed Belzona Superwrap II
3. Belzona Super wrap installed successfully.

The failed fiber glass was abraded with the aid of a power tool after which the surface was wiped clean using the cleaner/ degreaser Belzona 9111. After drying, Belzona 1212 was mixed and apply with Belzona Super wrap installed afterwards.

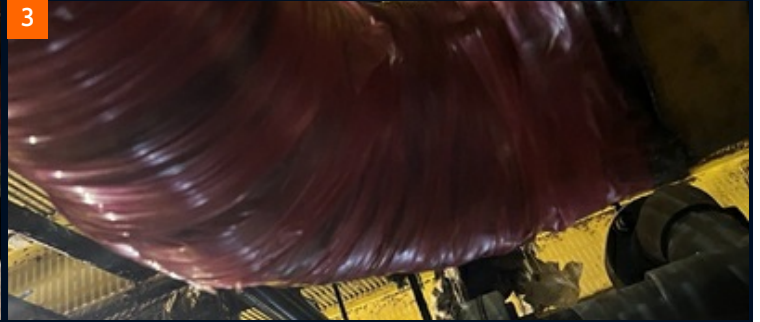
Belzona was not only able to seal the leak in a couple of minutes but also completed the whole installation and the equipment put back in service as stipulated in the product IFU. Follow up with customer confirmed that there was no leak or sipping as the Super wrap II successfully solve the issue.
