# PROCESS TANK SHELL CRACK LEAKAGE

ID: 9508

The customer has a horizontal crack on the shell of a process tank which is leaking.

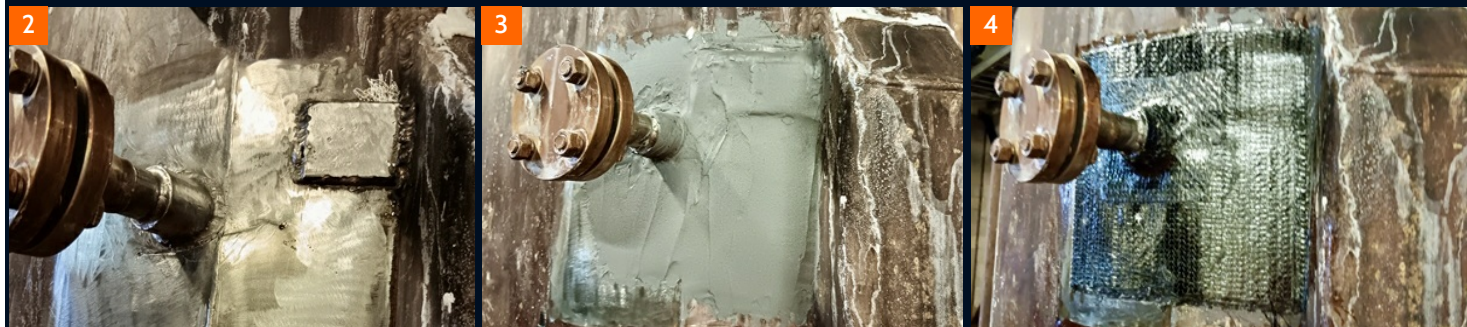
1. Manual preparation of the C.S. tank shell removing all contaminates and creating a cross-hatch profile for adhesion.
2. The cracked steel shell was caused by a knock on the nozzle which created an impression and cracked horizontally. The crack was terminated by drilling a small hole at the end of the crack.
3. mixed and applied Belzona 1511 Hi-temp, filler to smooth over the prepared area in readiness for the application of Belzona 1983 SuperWrap II
4. The completed SuperWrap II (1983) patch bonded in place over the Belzona 1511 and onto the steel Tank Shell.

The tank shell was cleaned and the surface prep, grinding with the cross-hatch method to create an acceptable profile, Belzona 1511 was mixed and applied by spatula, followed by an application of SuperWrap II.

Termination of tank shell cracks by drilling a small hole, filling the crack and surrounding area with Belzona 1511 prepares the job without any hot work, followed by SuperWrap II cold bonding technique.
