# AUTOMOTIVE ENGINE BLOCK REPAIR

ID: 9538

Cooling liquid leakage from engine block, on an Opel Astra J model, A14XER engine type.

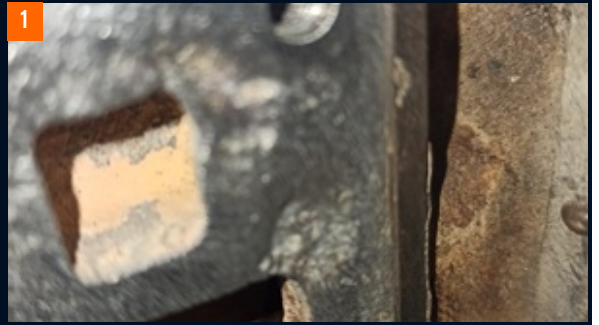
1. Initial condition with prepared surface
2. Start of application
3. Super Metal Application
4. Repair completed

Workshop cleaned and abraded the surface.
