# REPAIR OF IRRIGATION PUMP

ID: 9564

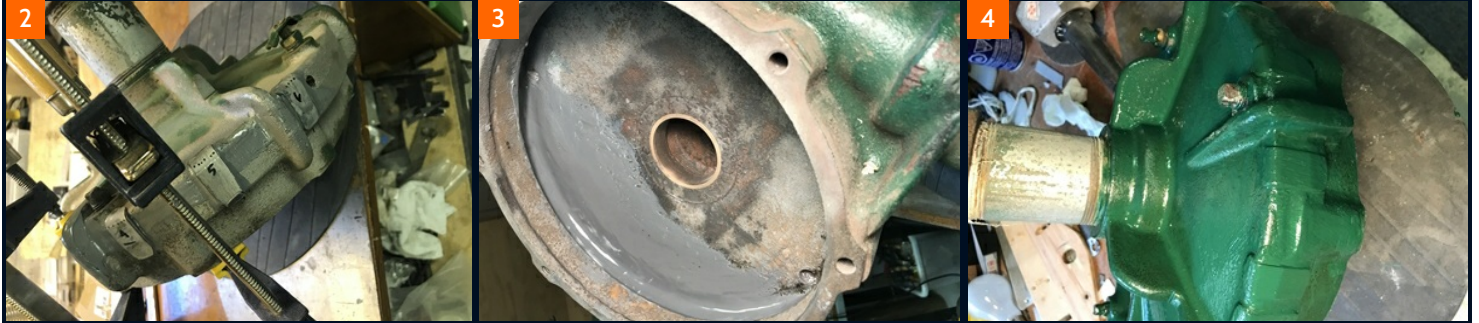
Pump was not drained preparatory to a cold winter freeze-over. The pump casing cracked catastrophically.

1. Depicts crack on pump casing.
2. Shows pump having had Belzona 1212 applied to the ground crack and 6 steel tabs bonded around the crack.
3. Inside of pump casing shows Belzona 1212 used to fill the crack and create a smooth finish for the water flow.
4. Belzona 1212 was applied throughout this repair. Finished job was painted.

The pump casing was hand ground along the crack. Two (2) holes were drilled to stop the crack propagation. The casing was slightly split to allow insertion of Belzona 1212, then clamped shut. The outside crack was filled with Belzona 1212, Six (6) steel tabs were bonded with Belzona 1212 to wrap the crack along its length and add strength to the repair. The pump was painted to complete the repair.
