# BELZONA REPAIRS CRACKED FLANGE

ID: 9574

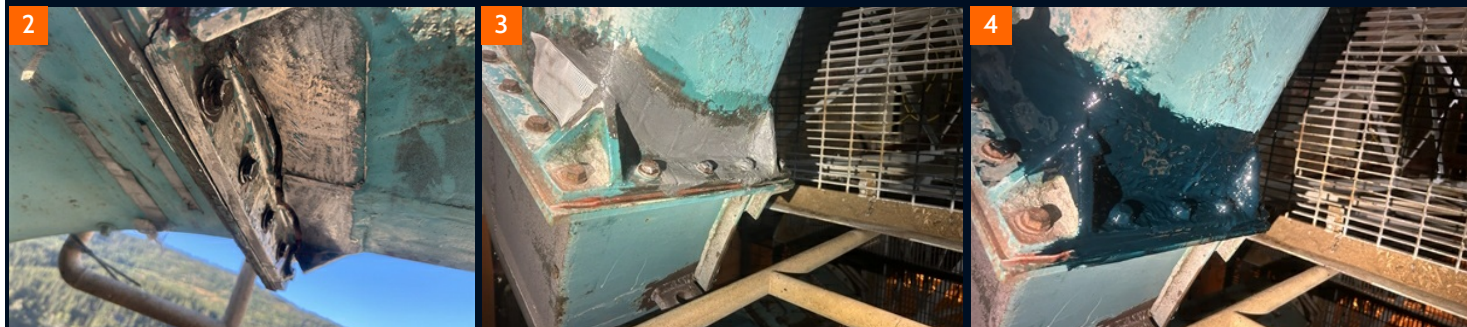
Overtighten flange led to cracked and damaged flange.

Flange cracked and was very damaged needed to get repairs during a 48hr shutdown

1. Equipment damage
2. Surface preparation completed
3. Rebuilt with Belzona 1311
4. Coated with Belzona 2141 for longevity

Cracked drill stopped and vee out. Prepares with grinding tools and cracks filled with Belzona 1311 and cloth. Overcoated with Belzona 2141 to provide expansion and contraction protection

Fast and efficient application for repair of a cast iron flange that was tile lined. Welding was not an option
