# CRACKED FLOOR REPAIR AND PROTECTION

ID: 9577

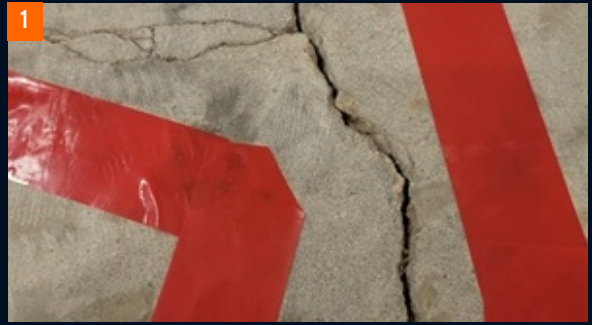
The customer's concrete floor had been cracked due to sub-base ground settlement. Customer wanted the cracks repaired and a protective coating applied for protection and aesthetic purposes.

The concrete floor was scarified, and the cracks were defined. Belzona 4911 conditioner was applied, and the cracks were repaired with 4111. Belzona 5231 was applied to the concrete floor using a roller. While the 5231 was still wet, decorative vinyl chips were broadcast onto the floor and a clean roller was used to press the vinyl flakes into the 5231. Belzona 5233 clear was applied over the vinyl flakes for a topcoat for mechanical protection and aesthetics.
