# FURNACE AIR INTAKE BLOWER

ID: 9588

## PROBLEM

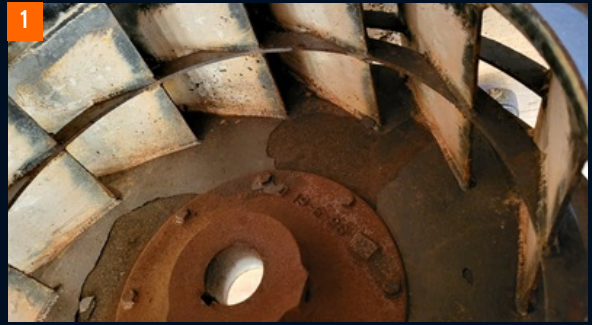
Infiltration of Perlite dust into the blower system causing very quick abrasive damage to blower fins.

These blowers were wearing quickly and often outpaced the scheduled maintenance period. Required unscheduled downtime in as little as 3 months use.

1. Worn blower, about half way through its usual lifespan, makeshift balancing bolts.
2. Blasted fan with 1311 reinforcing welds and filling holes and pits
3. 2 coats of 1321 on inside and all fins + welds. 2 colors as a wear indicator for inspection

Blower was grit blasted, plastic tool filling, brush applied coating. Baked in oven at 40C for quick return to service.
