# CREATING IRREGULAR SHIM FOR TRACKED SKIDDER AXLE

ID: 9589

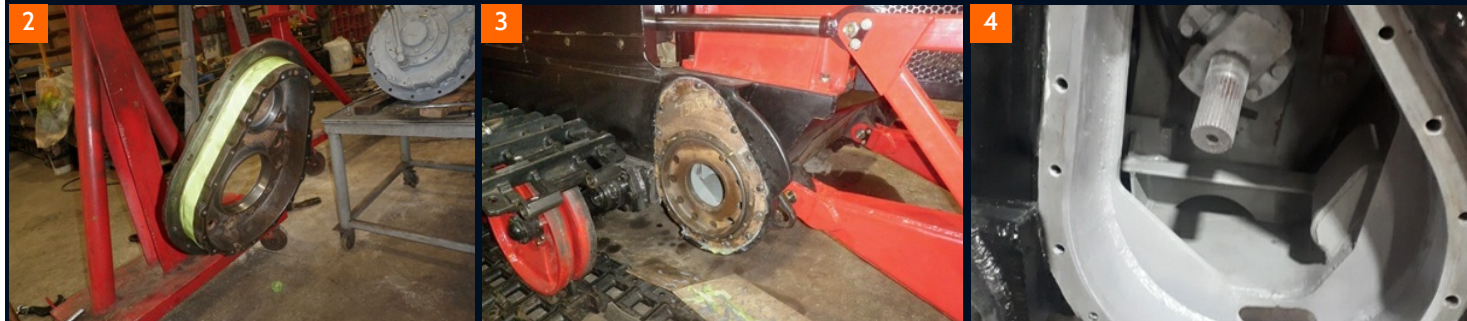
A tracked skidder used in forestry had sustained damage which distorted the frame, causing one track drive to be slightly out of alignment even after the frame had been straightened,

1. The final drive housing seat is not damaged, but it is out of alignment due to frame distortion. The mating surface will be cleaned and prepped with a mechanical blaster and all bolt holes corked, then Belzona 1111 will be applied over it.
2. A final drive housing with the mating flange coated with release agent is used as a former to create a new, properly aligned seat.
3. The drive housing is installed immediately after the Belzona 1111 is applied, and aligned while the product is still soft. Excess material is exuded, and it is allowed to cure.
4. When the drive housing is removed, the new, properly aligned seat is revealed.

Belzona offered a relatively fast and considerably less expensive option of properly aligning the final drive housing; the alternative was to strip the frame completely and attempt to re-straighten the frame, which would have taken several days and may or may not have been successful.
