# ACTIVATED CARBON TANK HOLE REPAIR

ID: 9595

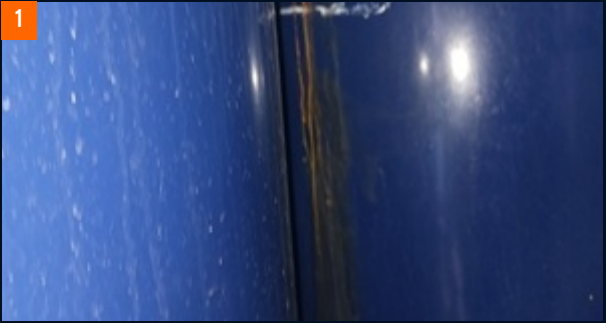
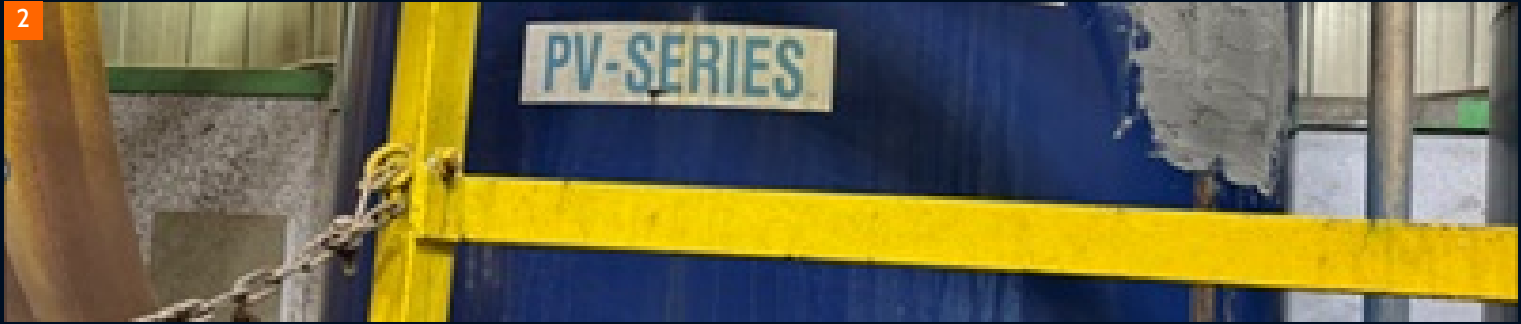
Tank which contains activated carbon was wearing off the tank and caused a hole which requires repair.

The pH value of the activated carbon is causing deterioration of the tank which further caused a hole. Customer was advised to use bonding of a metal plate of close thickness to the tank on the hole and covered with Belzona 1111.

- 1. Tank showing hole defect.
- 2. After repair.
- 3. Tank after plate bonding

Surface cleaning of the tank and metal plate was done using power tool. An applicator was used to apply Belzona 1111 on the metal plate and bonded to the tank. Additional application of the product was done on the plate afterwards.
