# REPAIR OF THE RUBBER PROTECTION OF THE DRYER.

ID: 9597

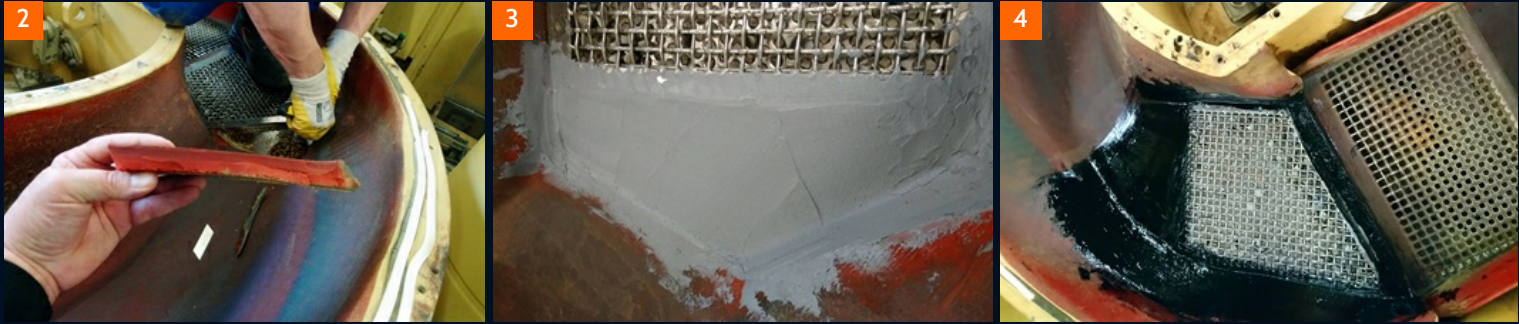
**PROBLEM**  
During the processing of the products, the rubber was damaged.

**APPLICATION SITUATION**  
The damaged part of the rubber in the dryer caused interruption of operation and damage to the products that were processed in the dryer.

- PHOTOS**
1. The damaged part of the rubber had to be removed.
  2. The damaged part was not large.
  3. The product Belzona 1212 and 1111 was used as a filler.
  4. Ready for production.

**APPLICATION METHOD**  
Removing the degraded part of the dryer's rubber padding. Mechanical cleaning of the surface using power tools. Vacuuming of abraded places with an industrial vacuum cleaner. Surface degreasing with Belzona 9121. Filling the space after removing the degraded part with sealants Belzona 1212 (1kg) and Belzona 1111 (1kg). Application of Belzona 2911 conditioner (QD Conditioner) to the prepared surface. A layer of Belzon 2111 (D+A HI – Build) was applied to the activated surface.
