# REPAIR OF DAMAGED IMPELLER EDGES.

ID: 9599

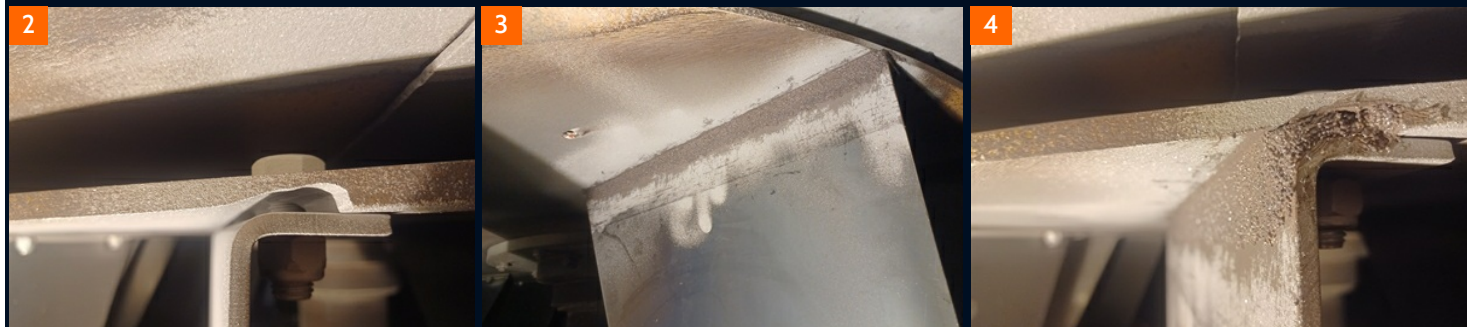
During the distribution of dusty construction materials, the edges and blades of the fan impeller are damaged.

Dusty material causes damage to the edges and blades of the fan. It was essential to find some solution to protect the fan from abrasion.

1. Dusty material causes damage to the edges and blades of the fan.
2. Detail of damage.
3. Fixed fan damage using Belzona 1812 product.
4. Repair detail.

Blasting the surface to the required standard Sa 2.5. Surface degreasing. Application of the product Belzona 1812 in a total thickness of approx. 6000 µm.

The damage reduced production productivity and caused production shutdowns. Application of the product Belzona 1812 in a total thickness of approx. 6000 µm prevented damage to the edges and shoveling of the fan.
