# BELZONA REPAIR OF POWER PUMP

ID: 96

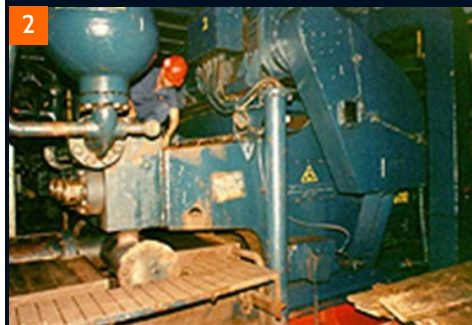
1. General view of the rig
2. The power pump
3. Application of Belzona to the pump casing
4. A re-faced flow block

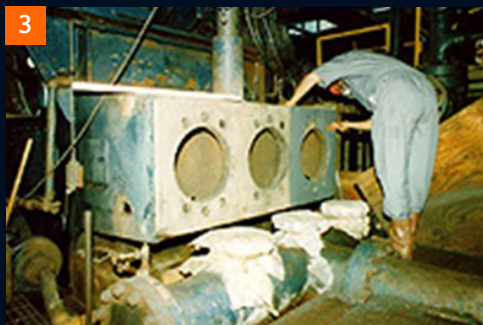
Corrosion of 2-4mm on the mating faces of the manifolds leading to leakage and loss of structural integrity
