# REPAIR OF DAMAGED GLASS FIBRE FLANGES

ID: 9602

## PROBLEM

Used tanks suffered severe damage to the glass fiber flanges.

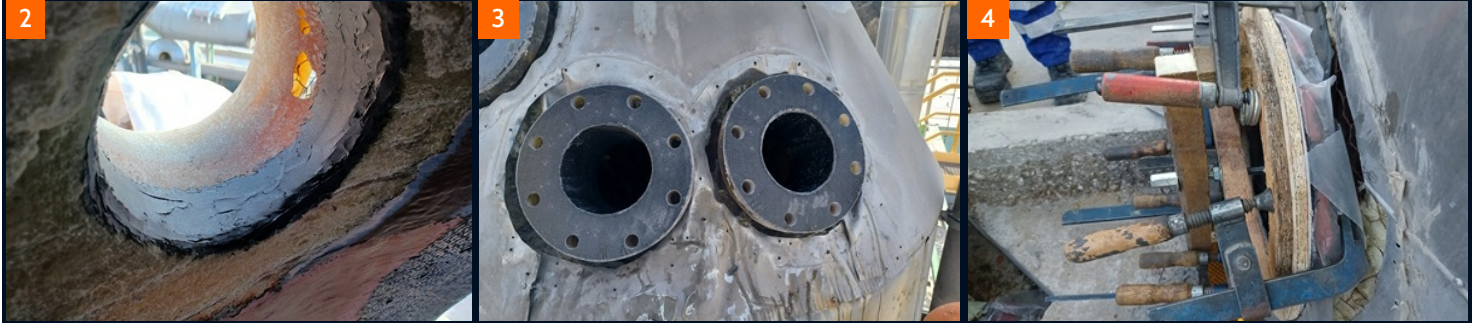
The tanks used by the customer are very old. They were made of glass fiber material. This was severely damaged due to abrasion and chemical attack, to the point where holes formed in the walls.

1. Severe damage to glass fiber necks and flanges
2. Filling the original missing material with Belzona 1111
3. Repaired flanges and necks - ready for use
4. An auxiliary structure had to be built to repair the flanges.

Surface blasting to Sa 2.5. Filling holes and lost material with Belzona 1111. Application of Belzona Super Wrap III 1981 + 9381.
