# BELZONA 1111 KEEPS THE CATTLE WATERED

ID: 9613

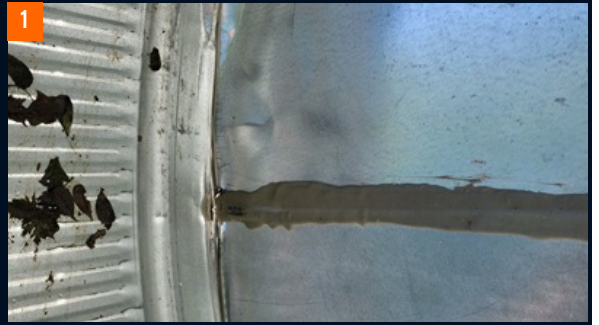
A farmers water trough was leaking. The welded seam was impacted which caused a large separation between the side and the bottom.

1. Original condition showing the cracked seam.
2. Surface prepped with a grinder and washed with solvent.
3. Application completed.
