# OIL COOLER REPAIR AND PROTECTION

ID: 9615

## PROBLEM

Due to severe corrosion and erosion, the tube sheet and lid were damaged.

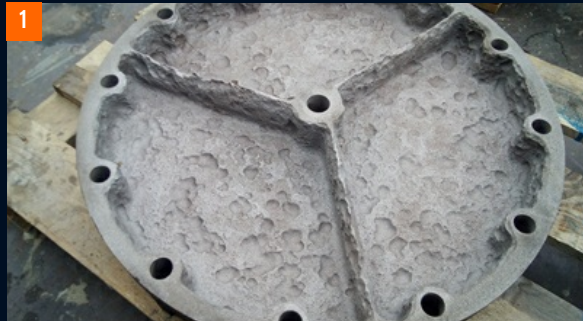
1. Heavily damaged exchanger cover
2. The repair was done using cork plugs.
3. Repaired and protected cover.
