# FAN WHEEL REPAIR

ID: 9619

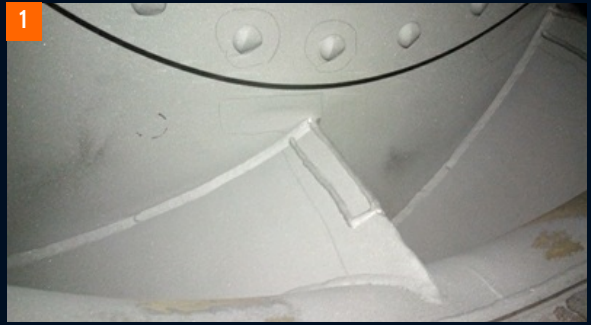
The abrasive material caused severe damage to the wheel

1. Wheel after blasting
2. Application of the product Belzona 1812 on the most affected areas
3. Application of the product Belzona 1812 on the fan blade
4. Since the repair was carried out in the winter, the fan had to be heated and the temperature had to be controlled.

Surface blasting according to the required Sa2.5 standard. Degreasing. Application of Belzona 1812 material on the cleaned surface of the device.
