# FAN WHEEL PROTECTION AGAINST STICKING

ID: 9620

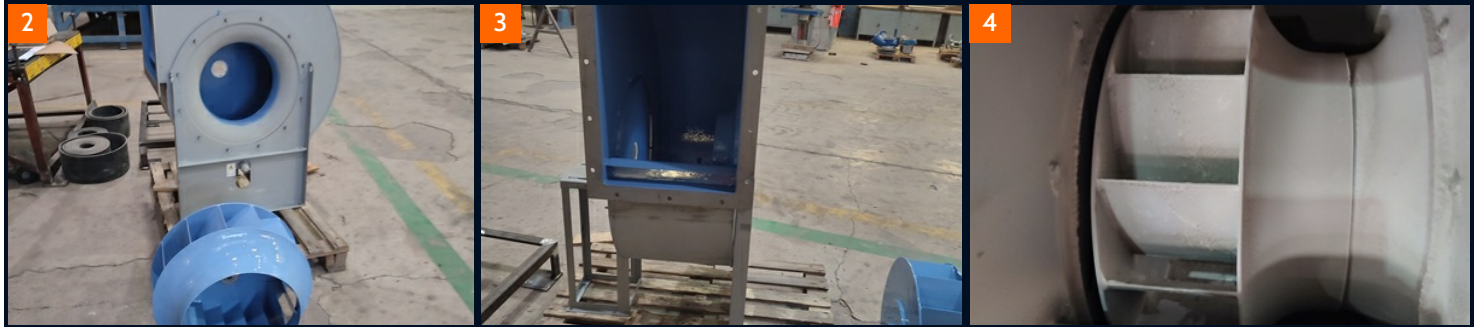
The sticky material caused the wheel to run erratically.

1. Fan wheel
2. Application of the product Belzona 1341 on the wheel
3. Application of the product Belzona 1341 on the fan box
4. Fan wheel before repair

Surface blasting according to the required Sa2.5 standard. Degreasing. Application of Belzona 1341 material on the cleaned surface of the device.
